**Flood Control Project Maintenance  
Levee Inspections**

**Maintenance Issue Types Only, Levee Inspection Report By Mile - Fall 2018**

**Reclamation District No. 2075 McMullin**

Waterway	Bank	Unit Miles	Inspection Start/End	Inspector
Unit No. 01 San Joaquin River	Right	7.45	11/09/2018 11/09/2018	Richard Willoughby

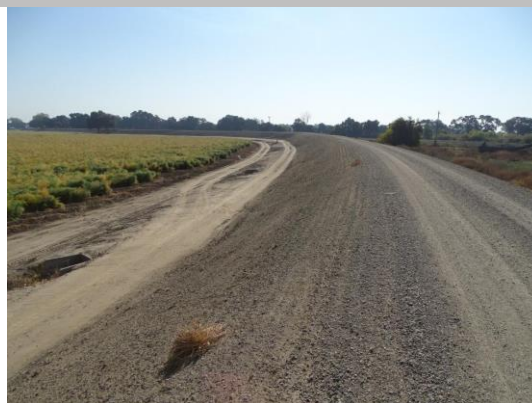
Photo 1 of 1 : FA\_2018\_RD2075\_315\_25\_20181126\_00066.jpg

LM Start	0.00	Rating **	A	Issue No.	25
LM End	7.43	Issue Type +	Ma	Location *	LS
Category	Earthen Levee			GPS Latitude/Longitude	
				Start	End
Item	Vegetation			37.748200 °	37.714162 °
				-121.289717 °	-121.259220 °
DWR ID	DWR_RD2075_01_f_2018_25				
Comment Code					
V1 : Control annual grass and weeds on the levee slopes and easements.					
Inspector Comment					
Vegetation on landward slope is acceptable expect from LM 1.43 to 1.63 issue # 29

Typical view of levee along landward slope. (Fall 2018)

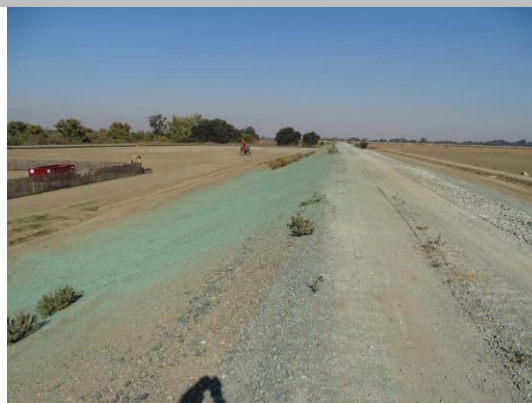
Photo 1 of 1 : FA\_2018\_RD2075\_315\_30\_20181126\_00067.jpg

LM Start	0.00	Rating **	A	Issue No.	30	
LM End	7.43	Issue Type +	Ma	Location *	WS	
Category	Earthen Levee			GPS Latitude/Longitude		
				Start		End
Item	Vegetation			37.748200 °		37.714162 °
				-121.289717 °		-121.259227 °
DWR ID	DWR_RD2075_01_f_2018_30					
Comment Code						
V1 : Control annual grass and weeds on the levee slopes and easements.						
Inspector Comment

Typical view of levee along waterward slope. (Fall 2018)

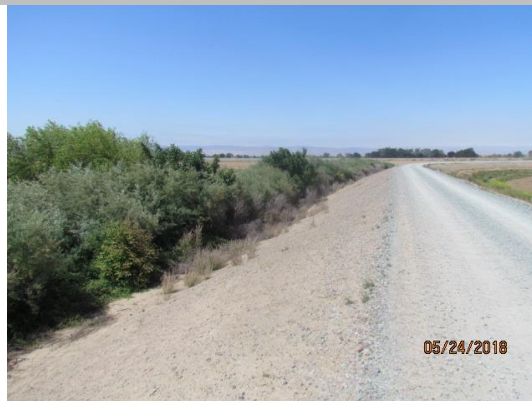
Photo 1 of 3 : FA\_2018\_RD2075\_315\_29\_20180906\_00042.jpg

LM Start	1.43	Rating **	U	Issue No.	29
LM End	1.63	Issue Type +	Ma	Location *	LS
Category	Earthen Levee			GPS Latitude/Longitude	
				Start	End
Item	Vegetation			37.735061 °	37.734213 °
				-121.284269 °	-121.287660 °
DWR ID	DWR_RD2075_01_s_2018_29				
Comment Code					
V2 : Remove the wild growth other than native grasses from the levee slopes.					
Inspector Comment					
Wild growth at landward toe blocking view and should cleared fifteen feet for landward toe.

Looking west at dense veg at landward toe. (Spring 2018)

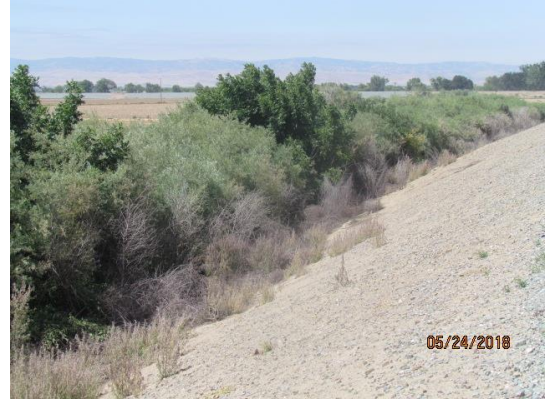
Photo 2 of 3 : FA\_2018\_RD2075\_315\_29\_20180906\_00043.jpg

Looking west at dense veg. at landward toe. (Spring 2018)

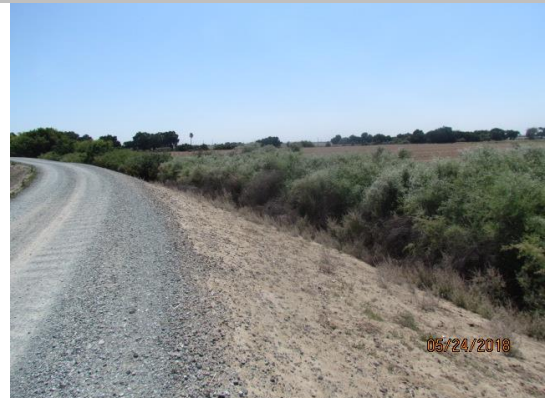
Photo 3 of 3 : FA\_2018\_RD2075\_315\_29\_20180906\_00044.jpg

Looking northeast at dense veg at landward toe. (Spring 2018)

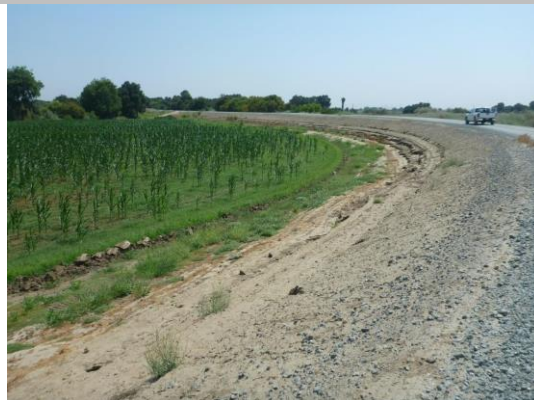
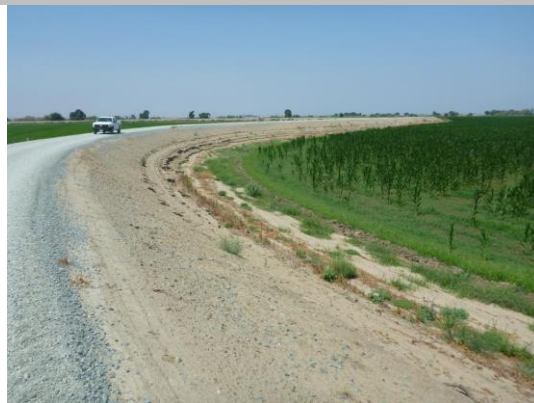
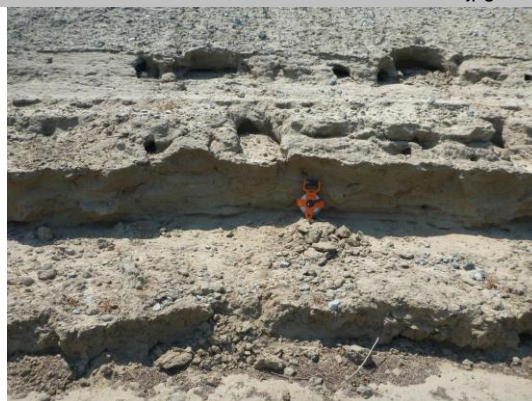
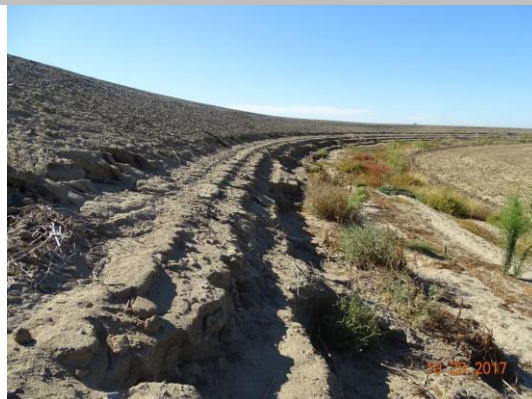
Description: Slope protection repairs are needed along the waterside slope due to erosion and riprap displacement from high water. Based upon levee inspections, it was determined the waterside levee slope is eroding, deteriorating, and degrading. The eroded levee sections need to be restored back to design standards to prevent further deterioration and damage.

Notes: 10/23/17: According to LMA and my observations at LM 1.63, this site never had riprap (contrary to previous comments). Erosion has encroached into levee prism. Future high water and wavewash will likely advance erosion further into prism. Repairs should be made prior to next high water.

10/23/17: According to LMA and my observations at LM 1.63, this site never had riprap (contrary to previous comments). Erosion has encroached into levee prism. Future high water and wavewash will likely advance erosion further into prism. Repairs should be made prior to next high water.

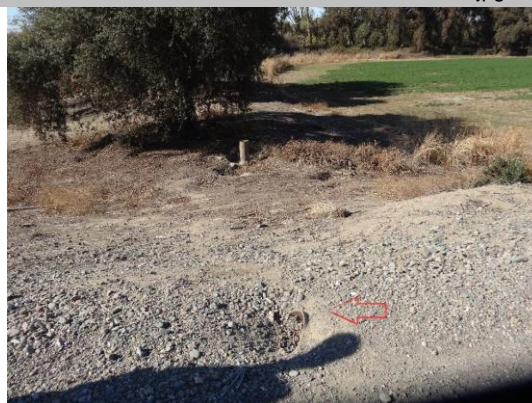
Photo 1 of 3 : UCIP\_FA\_2018\_24666\_45600.jpg

LM Start	2.32	Rating **	M	Issue No.	32
LM End	2.32	Issue Type +	Ma	Location *	
Category	Supplemental			GPS Latitude/Longitude	
				Start	End
Item	DWR UCIP LMA Responsibility			37.731314 °	37.731314 °
				-121.293713 °	-121.293713 °
DWR ID	24737				
Comment Code					
Inspector Comment					
FS_ID:24666 DS_ID:24737 EP_NO: N/A Repair Type: Non-Urgent Crossing Status: Found UCIP Comments: - service pole on landside.- looks abandoned. Walkway in dilapidated condition. FIELD_STRUCT_DESC: 16-inch steel drainage discharge pipe through the levee, 4.5 feet below the crown. Corrugated metal cutoff wall. Pump mounted on a pile structure in a drainage ditch on the landside (LS). Siphon breaker in a corrugated metal pipe (CMP) riser on the waterside (WS) slope. [Additional Reference(s): DWR Levee Log, 2005. USACE San Joaquin O&M Manual 3, December 1968, (HLM 2.30)]. FS Date: 11/13/2013

WS view: concrete standpipe (top) and steel pipe riser (bottom marked) on levee slope.

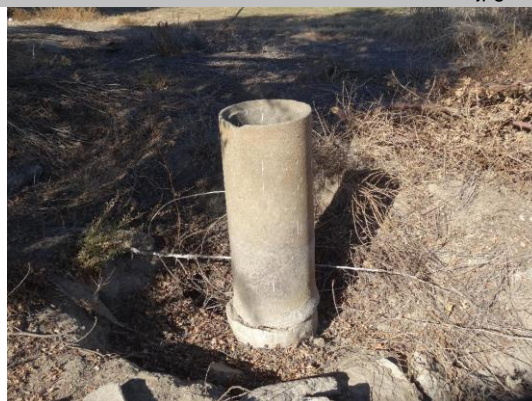
Photo 3 of 3 : UCIP\_FA\_2018\_24666\_44029.jpg

Comment Code						
Inspector Comment						
FS_ID:24666						
DS_ID:24737						
EP_NO: N/A						
Repair Type: Non-Urgent						
Crossing Status: Found						
UCIP Comments: - service pole on landside.- looks abandoned.						
Walkway in dilapidated condition.						
FIELD_STRUCT_DESC: 16-inch steel drainage discharge pipe through the levee, 4.5 feet below the crown. Corrugated metal cutoff wall. Pump mounted on a pile structure in a drainage ditch on the landside (LS).						
Siphon breaker in a corrugated metal pipe (CMP) riser on the waterside (WS) slope. [Additional Reference(s): DWR Levee Log, 2005. USACE San Joaquin O&M Manual 3, December 1968, (HLM 2.30)].						
FS Date: 11/13/2013

WS view: concrete standpipe on levee toe.

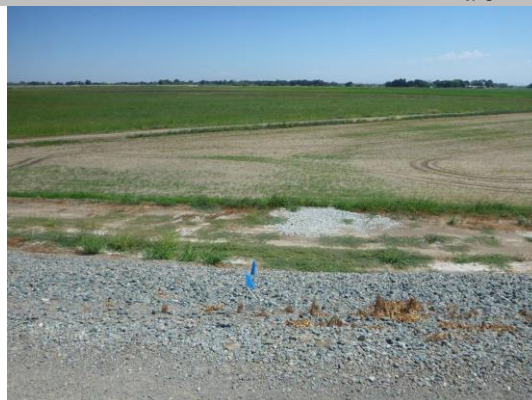
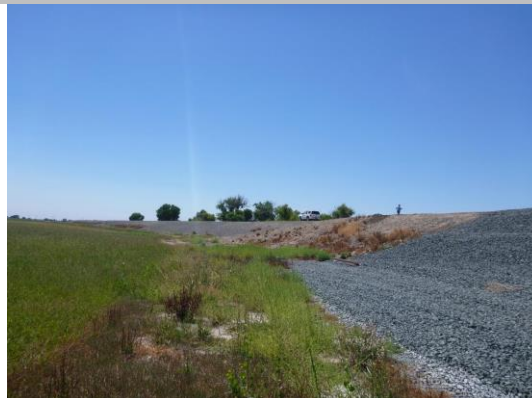
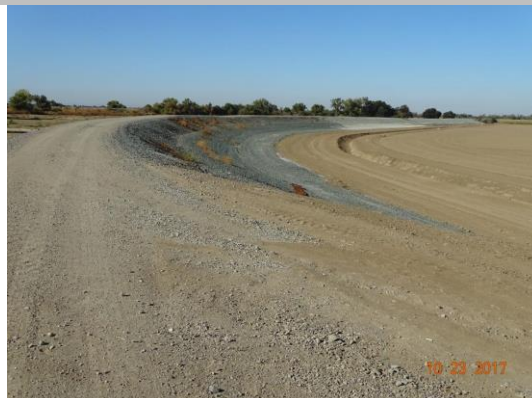
Comment Code					
Inspector Comment					
Levee Evaluation Comments					
Description:Sinkholes have formed along the landside levee toe as a result of the high water. The cause of the sinkholes is not clear, but a similar phenomenon in this area is believed to have caused the levee breach earlier this year. Further geotechnical investigation is needed.					
Site ID No:479					
Site Designation:LMA-306					
Repair Type: Stability					
Rating:Area of Concern					
Field Date:7/26/2017					
Notes: Sink holes appear to have already been filled. 10/23/17: LMA has removed pipes (parallel to levee) in this area, and drainage ditch has been relocated to approx 60 feet away from levee toe. Known sandy soils in region may contribute to sinkholes.

10/23/17: LMA has removed pipes (parallel to levee) in this area, and drainage ditch has been relocated to approx 60 feet away from levee toe. Known sandy soils in region may contribute to sinkholes.

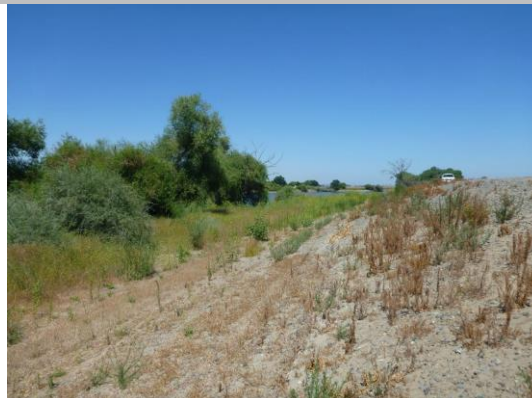
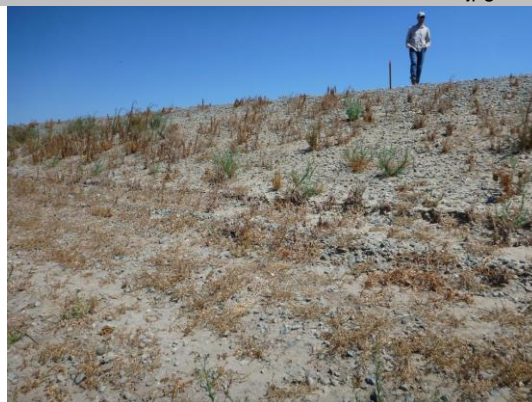
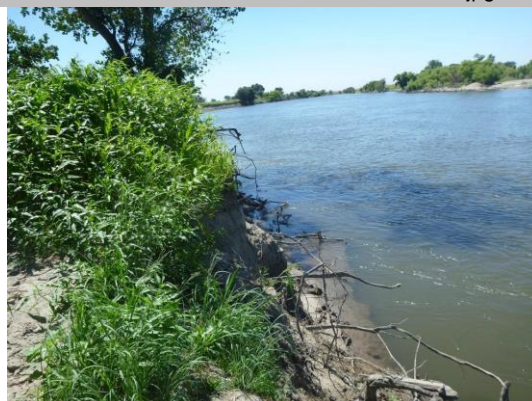
Description: Slope protection repairs are needed along the waterside slope due to erosion. Based upon levee inspections, it was determined the waterside levee slopes were eroding, deteriorating and degrading in concave pocket sections at various locations along this levee reach. The eroded levee sections need to be restored back to design standards to prevent further deterioration of the damaged levee sections.

Comment Code					
Inspector Comment					
Levee Evaluation Comments					
Description:Slope protection repairs are needed along the waterside slope due to erosion. Based upon levee inspections, it was determined the waterside levee slopes were eroding, deteriorating and degrading in concave pocket sections at various locations along this levee reach. The eroded levee sections need to be restored back to design standards to prevent further deterioration of the damaged levee sections.					
Site ID No:480					
Site Designation:LMA-307					
Repair Type: Erosion					
Rating:Area of Concern					
Field Date:7/26/2017					
Notes: Low priority because of the wide berm. Could not see all of the bank because of vegetation. Rock was placed on LS here during this years (2017) storms.

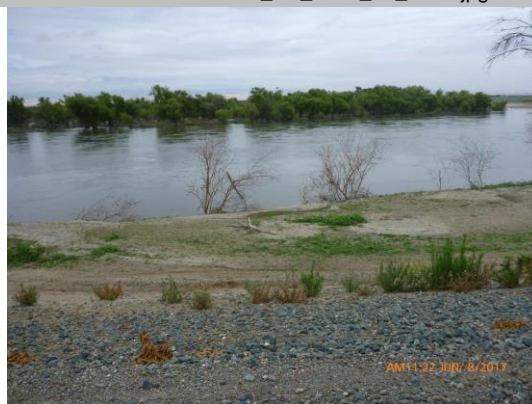
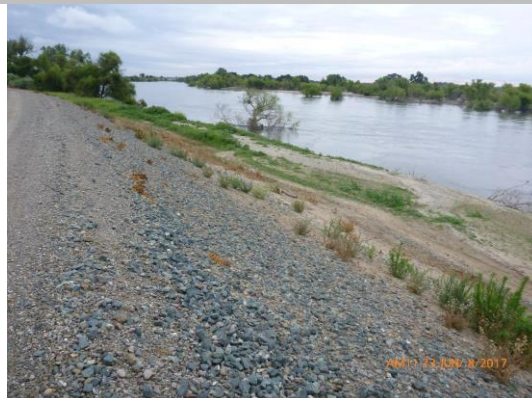
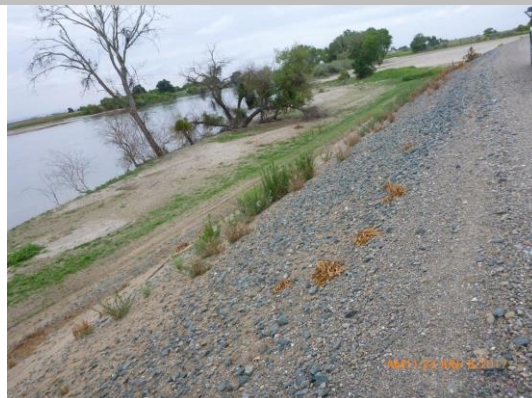
Notes: no damage present 10/23/17: Photos taken of vertical eroded low-flow bank approximately 20 feet from waterside levee toe. Area is composed of loose sand. Sandbar in channel may direct current toward this area.

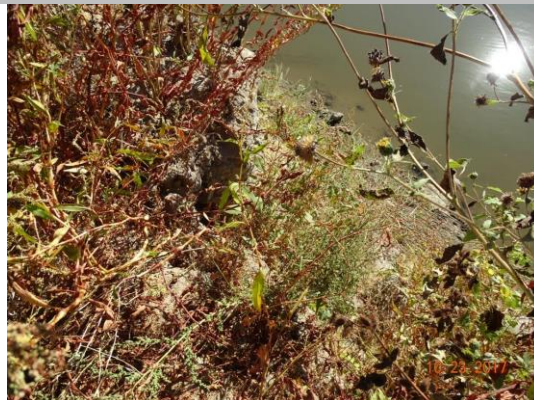
Photo 4 of 6 : FA\_2018\_RD2075\_315\_14\_20180906\_00012.jpg

View down through erosion rut in bank. 10/23/17: Photos taken of vertical eroded low-flow bank approximately 20 feet from waterside levee toe. Area is composed of loose sand. Sandbar in channel may direct current toward this area.

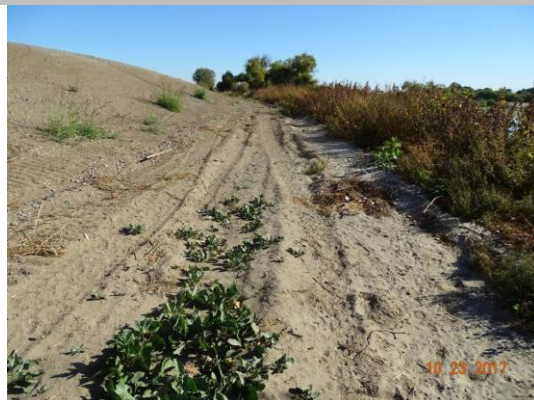
Photo 5 of 6 : FA\_2018\_RD2075\_315\_14\_20180906\_00013.jpg

View upstream showing narrow distance between levee toe and vertical bank. 10/23/17: Photos taken of vertical eroded low-flow bank approximately 20 feet from waterside levee toe. Area is composed of loose sand. Sandbar in channel may direct current toward this area.

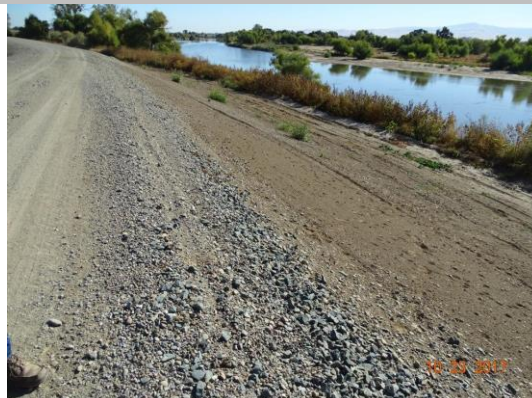
Photo 6 of 6 : FA\_2018\_RD2075\_315\_14\_20180906\_00014.jpg

View upstream showing narrow distance between levee toe and vertical bank. 10/23/17: Photos taken of vertical eroded low-flow bank approximately 20 feet from waterside levee toe. Area is composed of loose sand. Sandbar in channel may direct current toward this area.

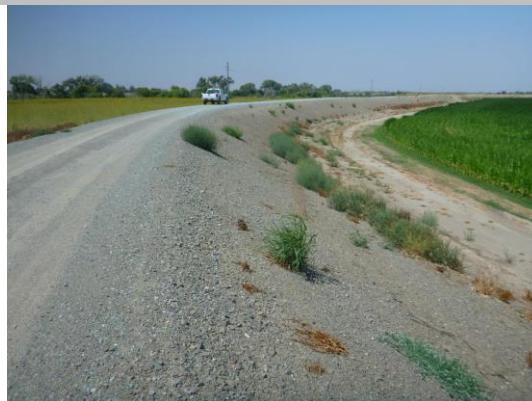
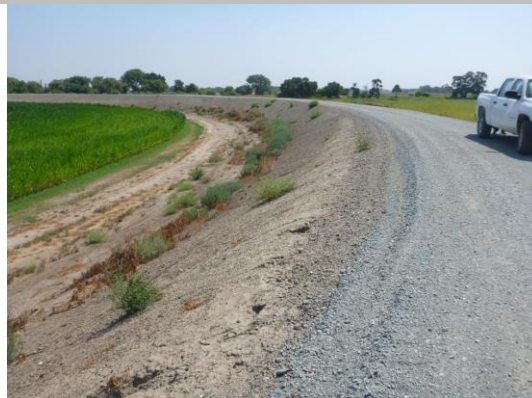
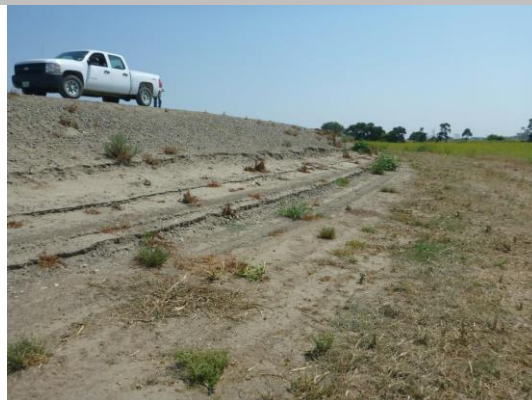
Comment Code					
Inspector Comment					
Levee Evaluation Comments					
Description:Slope protection repairs are needed along the waterside slope due to erosion and riprap displacement from high water. Based upon levee inspections, it was determined the waterside levee slope is eroding, deteriorating, and degrading. The eroded levee sections need to be restored back to design standards to prevent further deterioration and damage.					
Site ID No:576					
Site Designation:LMA-482					
Repair Type: Erosion					
Rating:Area of Concern					
Field Date:8/10/2017					
Notes: 10/23/17: There was no riprap in this area. Erosion sites have been repaired by LMA.

Description: Slope protection repairs are needed along the waterside slope due to erosion and riprap displacement from high water. Based upon levee inspections, it was determined the waterside levee slope is eroding, deteriorating, and degrading. The eroded levee sections need to be restored back to design standards to prevent further deterioration and damage.

Notes: 10/23/17: There was no riprap in this area. Erosion sites have been repaired by LMA.

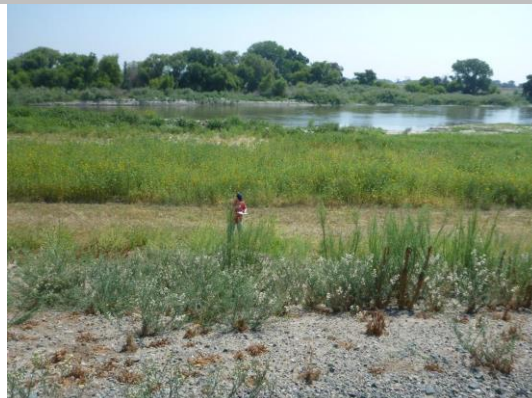
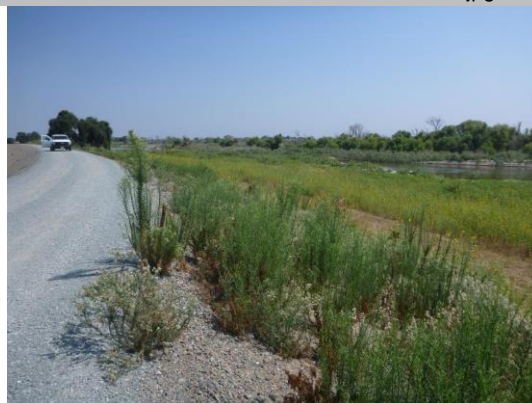
Description: Slope protection repairs are needed along the waterside slope due to erosion and riprap displacement from high water. Based upon levee inspections, it was determined the waterside levee slope is eroding, deteriorating, and degrading. The eroded levee sections need to be restored back to design standards to prevent further deterioration and damage.

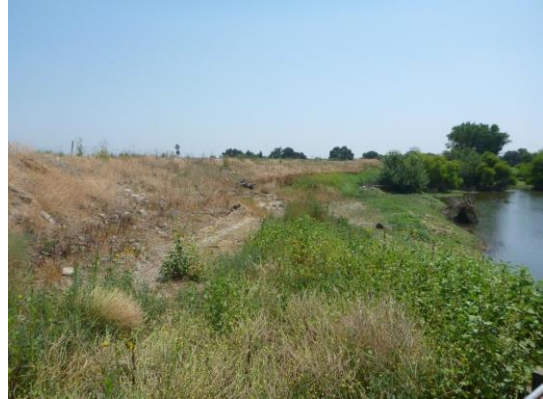
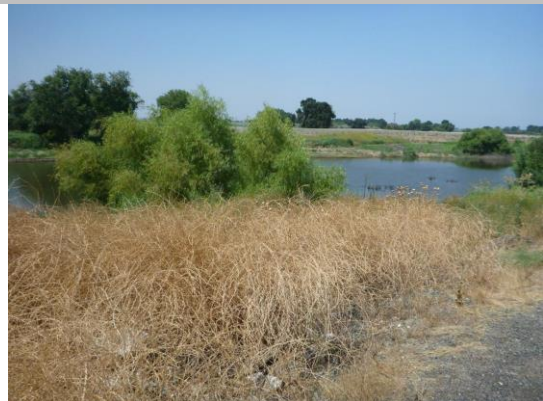
LM Start	5.24	Rating **	A/W	Issue No.	21
LM End	5.29	Issue Type +	Ma	Location *	WS
Category	Supplemental			GPS Latitude/Longitude	
				Start	End
Item	2017 Storm Damage			37.728460 °	37.727799 °
				-121.274671 °	-121.274252 °
DWR ID	DWR_RD2075_01_f_2017_21				
Comment Code					
Inspector Comment					
Levee Evaluation Comments					
Description:Slope protection repairs are needed along the waterside slope due to erosion and riprap displacement from high water. Based upon levee inspections, it was determined the waterside levee slope is eroding, deteriorating, and degrading. The eroded levee sections need to be restored back to design standards to prevent further deterioration and damage.					
Site ID No:578					
Site Designation:LMA-484					
Repair Type: Erosion					
Rating:Area of Concern					
Field Date:8/10/2017					
Notes: Paved road on levee.

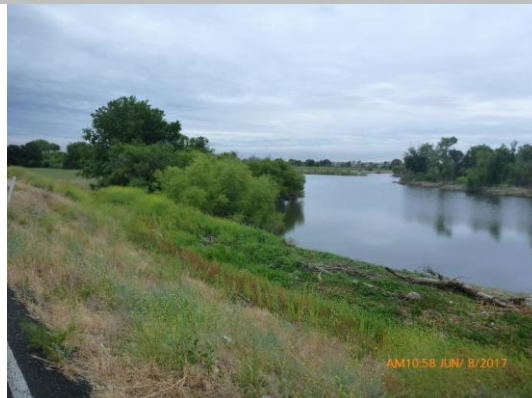
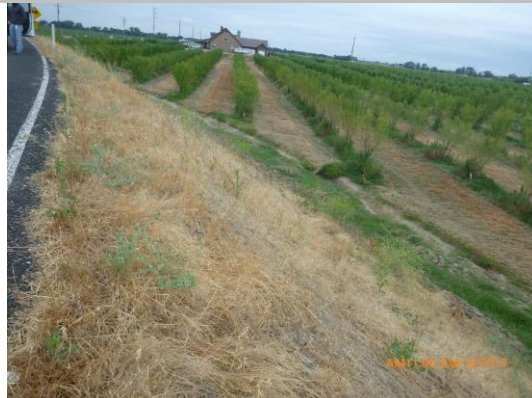
LM Start	5.26	Rating **	A/W	Issue No.	23 (cont)	
LM End		Issue Type +	Ma	Location *	WS	
Category	Supplemental			GPS Latitude/Longitude		
				Start		End
Item	2017 Storm Damage			37.728216°		°
				-121.274434°		°
DWR ID	DWR_RD2075_01_f_2017_23					
Comment Code						
Inspector Comment						
Levee Evaluation Comments						
Description:						
Site ID No:79						
Site Designation:LMA-33						
Repair Type: Erosion						
Rating:Area of Concern						
Field Date:6/8/2017						
Notes: no damage present

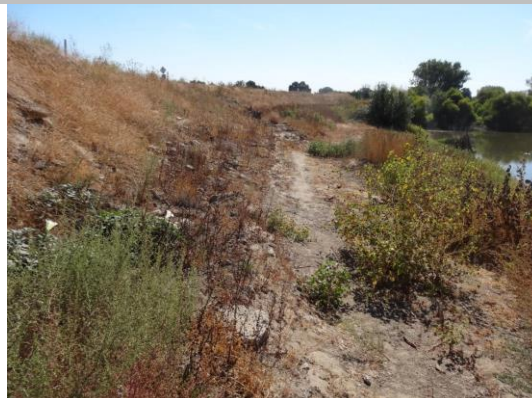
Photo 1 of 3 : FA\_2018\_RD2075\_315\_1\_20180906\_00001.jpg

Comment Code					
Inspector Comment					
09/13/2017: No significant change observed.					
07/12/2016: No significant change observed.					
08/28/2015: No significant change observed. Loose material is visible at the upper levee slope. The loose soil may have been caused by runoff.					
08/18/2014: No significant change observed.					
09/10/2013: No significant change observed.					
09/13/2012: No significant change observed.					
08/18/2011: No significant change observed. Some new material added to the water side levee slope, but the added material is loose and seems not helping the levee protection.					
10/05/2010: No significant change observed. Levee slope has minimal vegetation and lacks rip rap protection. Sandy material found on the lower and middle slope is an undesirable material to have on a levee.					
08/05/2010: Recommended for annual assessment and monitoring during flood events, per CLRO.

08/20/2009: No major change since last visit; site is located in an oxbow; slope surface consists of very sandy material; there is a tree on site leaning and with exposed tree roots; site is recommended as a local maintenance issue, per CLRO CES Evaluation 2008 Report; Eddy Cordoza from the district is aware of the site and is looking for recommendation; site is previously rated "U".					
08/17/2007: Site is close to an irrigation pump inlet. [2017 Site ID:RD2075U01RM64.34]

Upstream view of the erosion site.

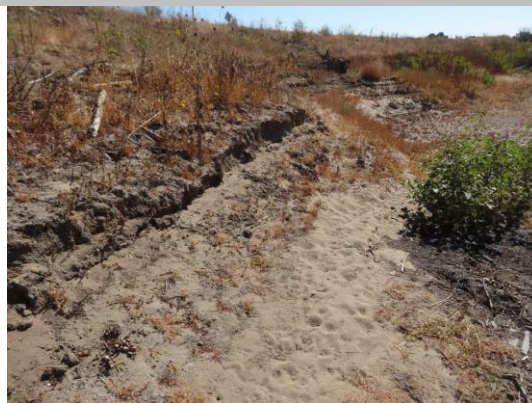
Photo 2 of 3 : FA\_2018\_RD2075\_315\_1\_20180906\_00002.jpg

Close view of the site.

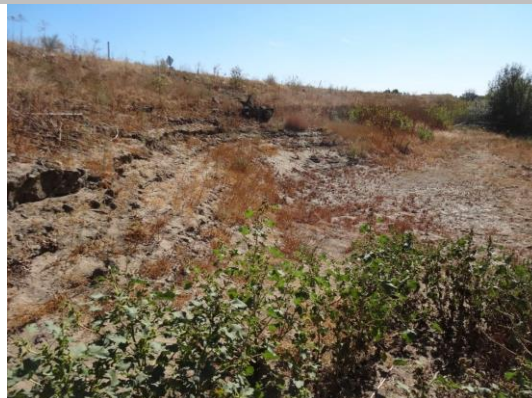
Photo 3 of 3 : FA\_2018\_RD2075\_315\_1\_20180906\_00003.jpg

Item	DWR Erosion Survey			37.727933 °	37.727933 °	
				-121.274491 °	-121.274491 °	
DWR ID	RD2075U01RM64.34					
Comment Code						
Inspector Comment						
09/13/2017: No significant change observed.						
07/12/2016: No significant change observed.						
08/28/2015: No significant change observed. Loose material is visible at the upper levee slope. The loose soil may have been caused by runoff.						
08/18/2014: No significant change observed.						
09/10/2013: No significant change observed.						
09/13/2012: No significant change observed.						
08/18/2011: No significant change observed. Some new material added to the water side levee slope, but the added material is loose and seems not helping the levee protection.						
10/05/2010: No significant change observed. Levee slope has minimal vegetation and lacks rip rap protection. Sandy material found on the lower and middle slope is an undesirable material to have on a levee.

Looking upstream at the site.

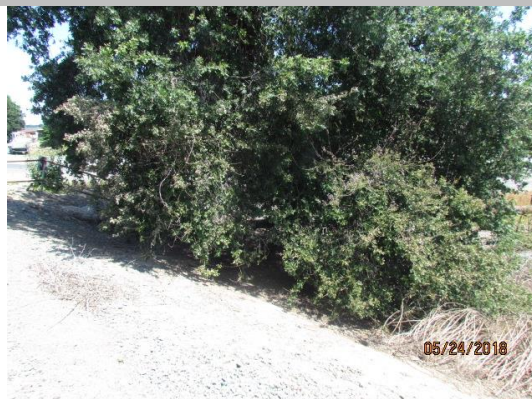
Photo 1 of 1 : FA\_2018\_RD2075\_315\_22\_20180906\_00035.jpg

LM Start	5.57	Rating **	U	Issue No.	22
LM End	5.57	Issue Type +	Ma	Location *	LS
Category	Earthen Levee			GPS Latitude/Longitude	
				Start	End
Item	Trim / Thin Trees			37.724795 °	37.724795 °
				-121.270935 °	-121.270935 °
DWR ID	DWR_RD2075_01_s_2018_22				
Comment Code					
T1 : Trim trees to at least five feet above ground level.					
Inspector Comment

Looking downstream at untrimmed tree on landward toe. (Spring 2018)
